Wilson Creek - Mankato

Preliminary Findings and Recommendations

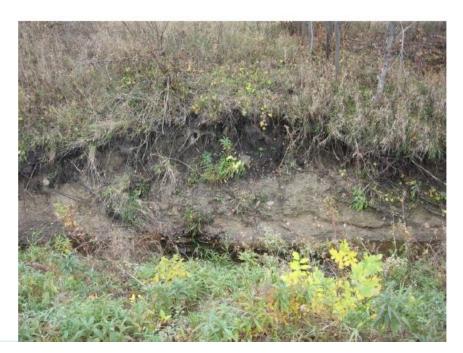
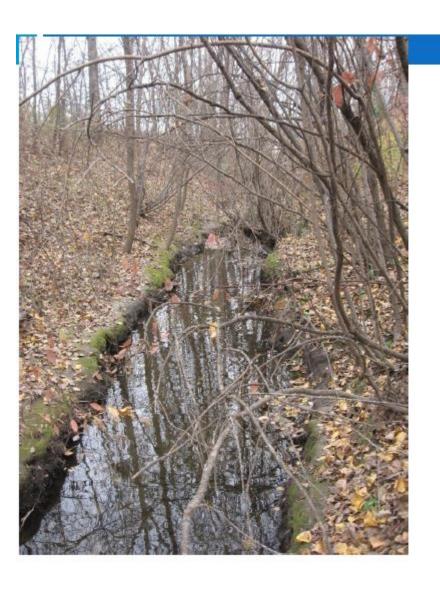
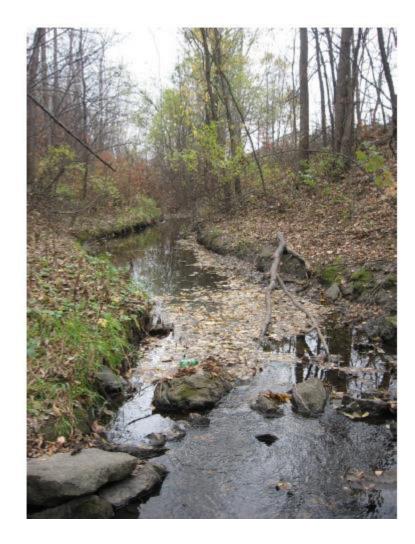
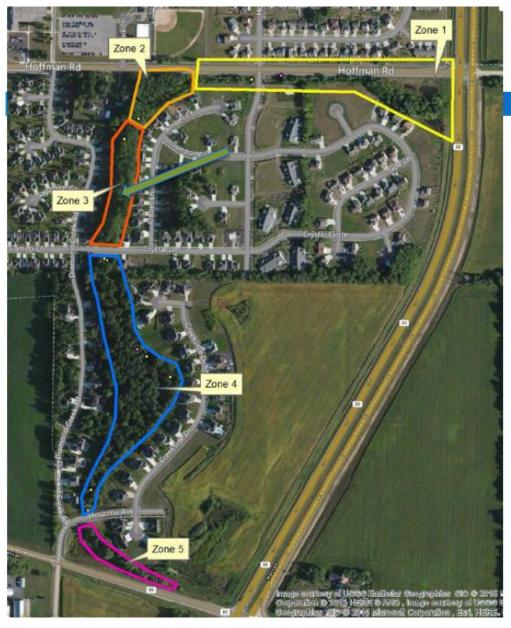
- Identified needs:
 - Potential slope failures and sloughing
 - Relatively steep banks, near traveled way
 - High velocities
- Potential improvement
 - Continued vegetation management
 - Flow reduction

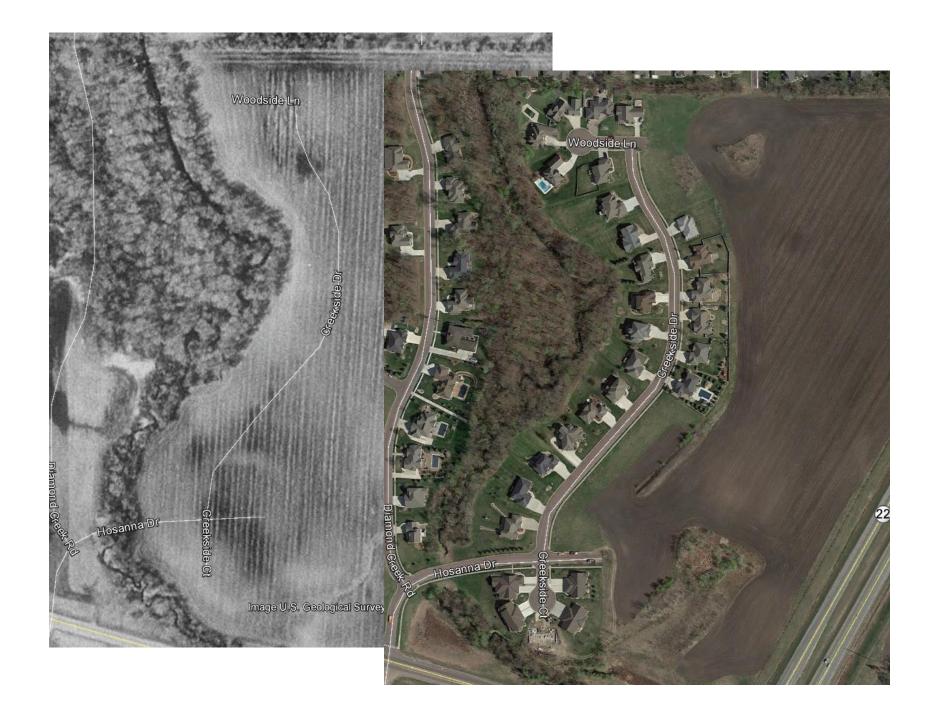
- Common Issues to Developing Urban Areas
 - Vegetation Decay / Overgrowth
 - Debris and Excess Sediment
 - Stream Widening and Bank Erosion
 - Increased Flood Frequency
- Natural Processes Enhanced by rapid land use changes
 - Bank Erosion due to Channel Migration (active meanders)
 - Wood Debris Accumulation
